Monitoring Data RecordProject Title: U-4026B (Davis Drive) COE Action ID: 200120448Stream Name: Tributary to Burdens Creek (Site 9) DWQ Number: 051972City, County and other Location Information: Durham County, Davis Drive (Sta. 284+50RT.)Date Construction Completed: 12/5/07 Monitoring Year: (3) of 5Ecoregion: _____ 8 digit HUC unit 03030002

Tributary to Burdens Creek

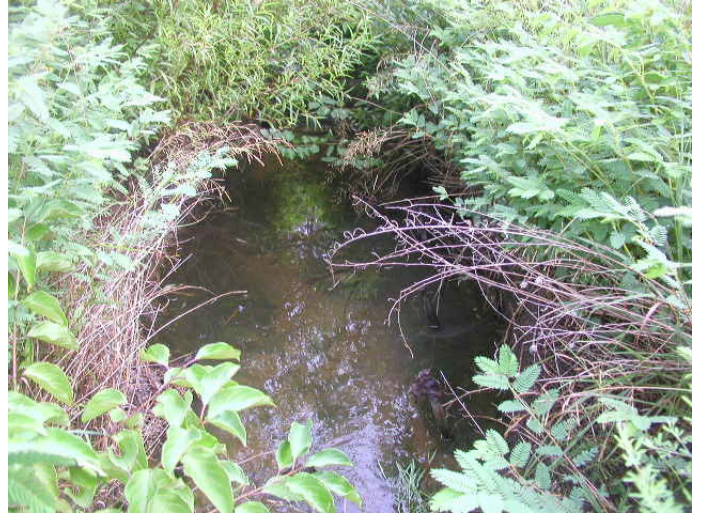
The Tributary to Burdens Creek is stable for the Year 3 Summer evaluation, except for two slight headcuts that have formed at Stations 284+50 (Photo Point #1 Downstream) and at Station 285+50. The headcuts have not changed since the winter evaluation and these areas remain stable. NCDOT personnel met onsite on 5/11/09 to discuss possible options for corrective action. It was decided at that time that corrective action was not necessary and NCDOT would continue to monitor the stream relocation.

Date Inspected 7/28/10	Station Number Sta. 284+50 Photo Point #1 (Downstream)	Station Number Sta. 285+50 Additional photo	Station Number	Station Number	Station Number
Structure Type		Crossvane			
Is water piping through or around structure?		Water is flowing under crossvane			
Head cut or down cut present?	Slight Headcut	Slight Headcut			
Bank or scour erosion present?					
Other problems noted?

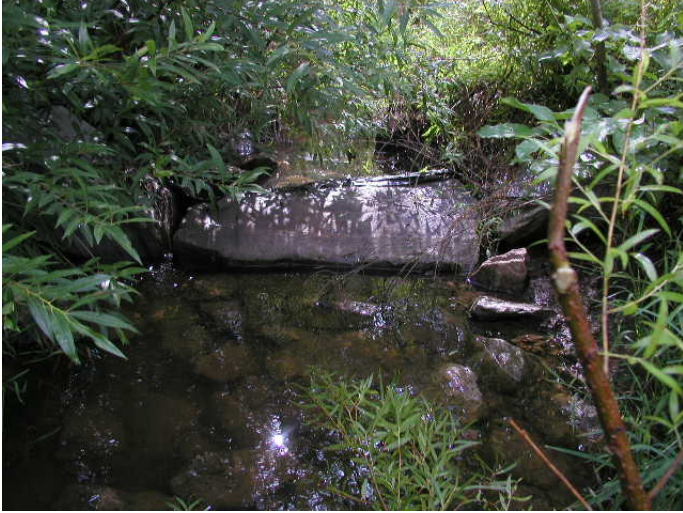
Water is flowing under a crossvane and a slight headcut has formed at Sta. 285+50 which is downstream of Photo Point #3
